TE-DGH/TE-DGHC (CMOS)

**RAM 1500 (2009-2017)
RAM 2500 (2010-2017)**

Replacement Tailgate Handle with Camera

Removal and Installation Instructions

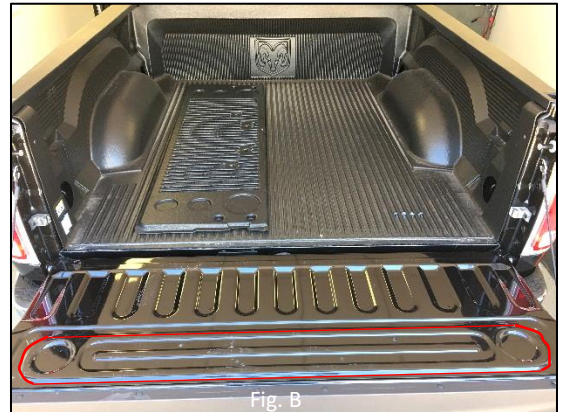
1. Start by lowering the tailgate and remove the (8) T30 torx screws from the bed liner, remove liner (Fig. A), remove access panel (Fig. B), and place aside.
2. Now that you have access to the handle assembly, disconnect harness running to lock actuator and unclip (2) latch rods. (Fig. C)
3. Next, remove (2) 8mm nuts located below latch connectors, then slide latch assembly aside. (Fig. C)
4. Gently remove handle by lifting the handle from the outside and slowly working it out.
5. Now that the handle is out of the tailgate, you will have to swap the locking mechanism out of the old handle to the new one.
6. Start by removing the (2) 8mm screws from locking mechanism, and then remove mechanism from handle. (Fig. D)
7. Now place the locking mechanism in the new handle and secure it with the factory 8mm screws.

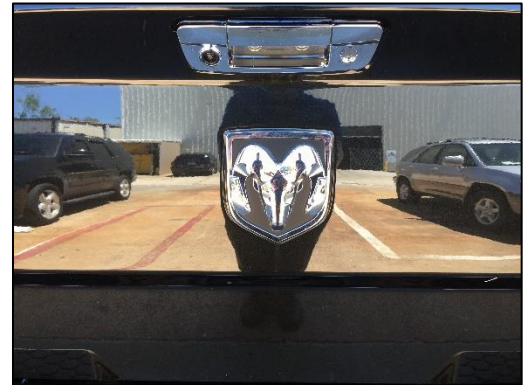
8. Next, remove taillight and splice the red power wire from the camera's harness into the reverse light's 12v positive wire. This will trigger the camera to turn on when vehicle is placed in reverse. Attach the black ground wire to a metal non-painted surface.
9. Wires can now be fully routed from the tailgate to the cab of the truck and to a video source, securing every 16". The Yellow RCA will plug into the input of your video source; the Red wire goes to the rear camera input trigger wire on your video source.

10. Now gently reinsert new tailgate handle and route cable trough tailgate.

11. Realign the handle's post with latch assembly opening mechanism and reattach 8mm nuts to secure handle in tailgate.

12. Reconnect harness to lock actuator and reattach latch rods, then reattach the tailgate's access panel and bed liner cover to complete your install.
